REVOLUTION
HELICOPTER CORP., INC.

Revolution Helicopter Airworthiness Directive (AD) #070795

Effected Aircraft: All Mini-500 helicopters.

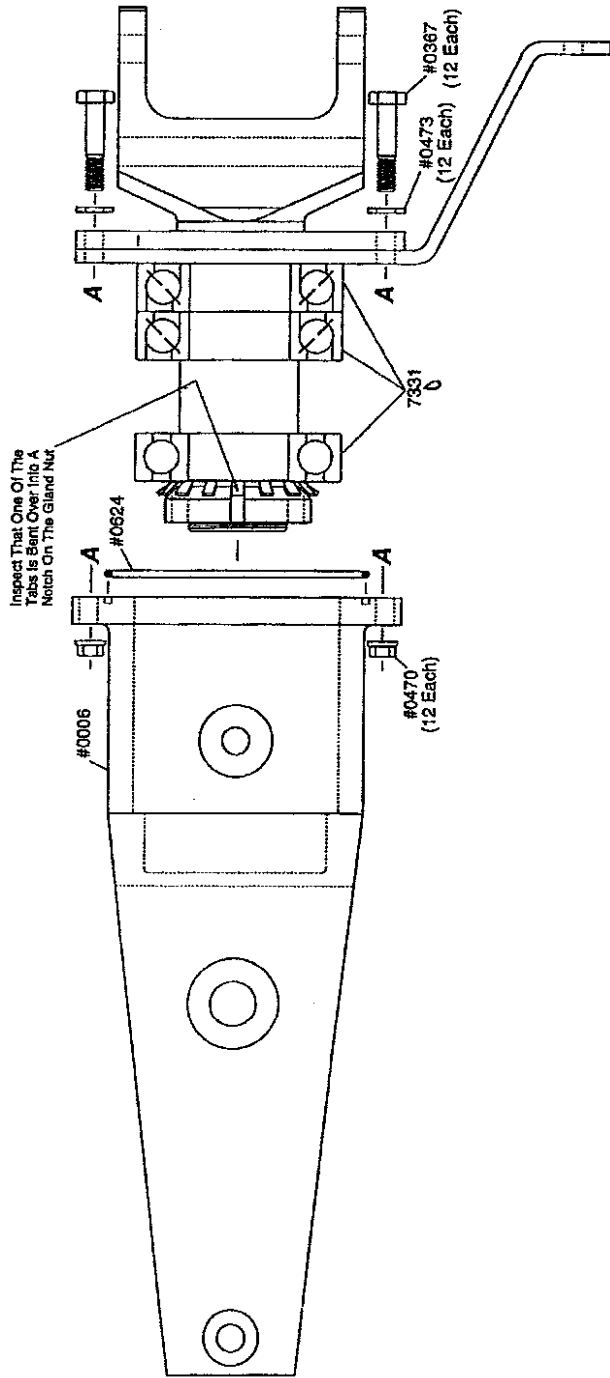
Fig 1 - Disassembled View For A.D Compliance

Subject: Main rotor cones. It has been discovered that the locking ring for the gland nut, on the end of the spindle inside the rotor cone, may not have had the tab bent over into the locking groove on the nut.

6. Check to insure that one of the tabs on the locking ring is bent up into the slot in the gland nut. See Fig. 1.
 7. If the tab is not bent into place, then bend one tab into the slot in the gland nut. If the slot in the gland nut doesn't line up with one of the tabs on the locking ring, tighten the nut until the slot does line up.

Corrective Action: The locking ring on the spindle must be inspected to insure that the tab has been bent into the groove on the gland nut. You may either send your main rotor cone assemblies to Revolution Helicopter and we will complete the inspection, or you may follow the attached instructions and complete the inspection yourself.
