Revolution Helicopter Airworthiness Directive (AD) #081997

Affected Aircraft: All Mini-500 helicopters shipped on or before June 16, 1997, except for aircraft serial #0346, #0351, #0357 and #0430.

Subject: Cyclic Upgrade

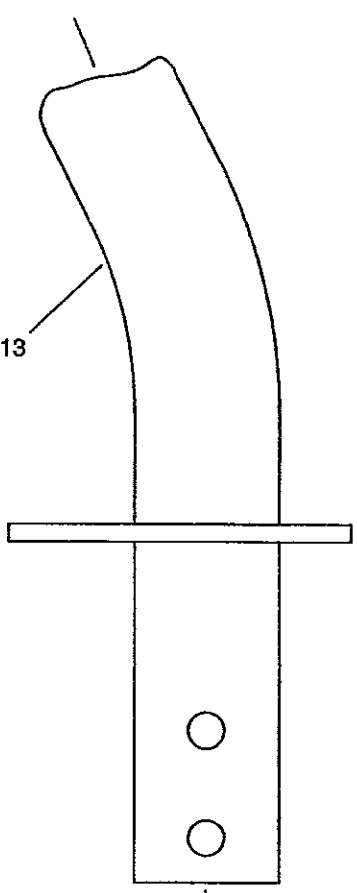
In some isolated cases, we have had reports of the cyclic #BA13 developing a small amount of play inside the socket of part #0151 after use. Although this play does not represent a short-term problem, it can be responsible for cyclic stick shake and some rotor system vibration.

1. Remove the cyclic #BA13 by unbolting it from part #0151.
2. Insert the new part #0738 into the bottom of the cyclic #BA13. Use a high-quality adhesive to permanently install part #0738 into the cyclic #BA13.
3. Reinstall the cyclic #BA13 into part #0151 and bolt in place. Continue operation.
