Revolution Helicopter Airworthiness Directive (AD) #082096

Effected Aircraft: All Mini-500 Helicopters shipped before August 20, 1996.

AD Type: Urgent (Must be complied with before further flight.)

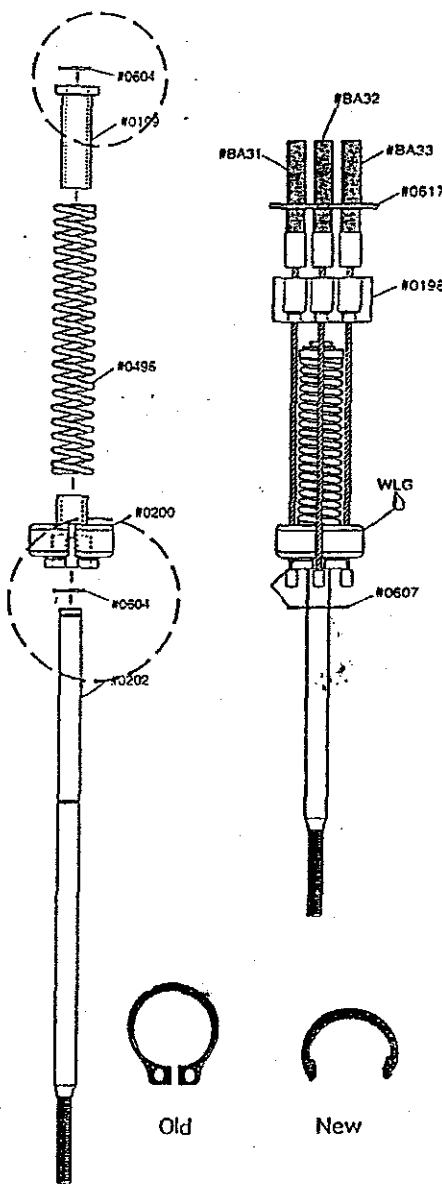
Subject: When installing snap rings #0604 onto junction box shaft #0202, some customers are expanding the snap rings too much when sliding them over the shaft. The snap rings are not contracting back to their original size and do not fit tightly into the groove. If one of the snap rings should pop loose in flight, the engine will go to full throttle. The only option would then be to shut off the engine to prevent a rotor over speed.

Corrective action: We have changed to a different snap ring that does not have to be expanded during installation. You simply push the snap ring into the groove. This new snap ring is much stronger and easier to install correctly. All existing kits must be updated with the new snap rings before further flight. Updated snap rings are supplied with this AD. Refer to this drawing and section 5 page 17 of your assembly manual. Discard the old snap rings.
