REVOLUTION HELICOPTER CORP., INC.

Revolution Helicopter Service Information Letter # 09191997

Affected Aircraft: All Mini-500 helicopters.

Subject: Optional Cyclic Bell Horn Modification.

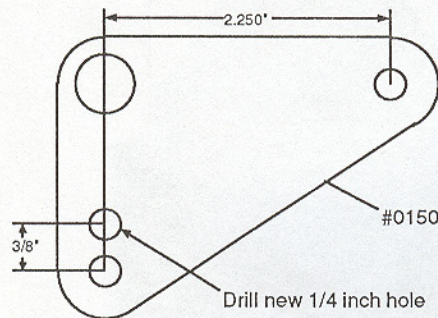
Through the ongoing factory testing and evaluation program carried out on the Mini-500 helicopter, RHCI will occasionally find ways to improve the Mini-500's flight characteristics. It has been discovered that with a small modification made to the cyclic bell horns (#0150), as seen in the Mini-500 Assembly Manual on Section 5, page 15 and 16, Fig. 30 and 31, will reduce the amount of fore-and-aft movements required, and allows for a more comfortable control range of movement.

1. Disassemble and remove the cyclic bell horns (#0150) from the control system.
2. Place both #0150 together, and align with bolts or pins for accuracy.
3. Mark and drill a 1/4 inch hole through both parts, 3/8 inch away from center of previous 1/4 inch hole, as shown in drawing provided.

4. Reassemble both #015 to control system, and connect #BA12 assembly into new hole. Insure that all rod-ends are attached with ample threads, and jam-nuts are tight!
5. It may be necessary to adjust cyclic position to your comfort.
