HELICOPTER CORP., INC.

Mini-500

Service information letter #040196

Subject: Belt Tracking

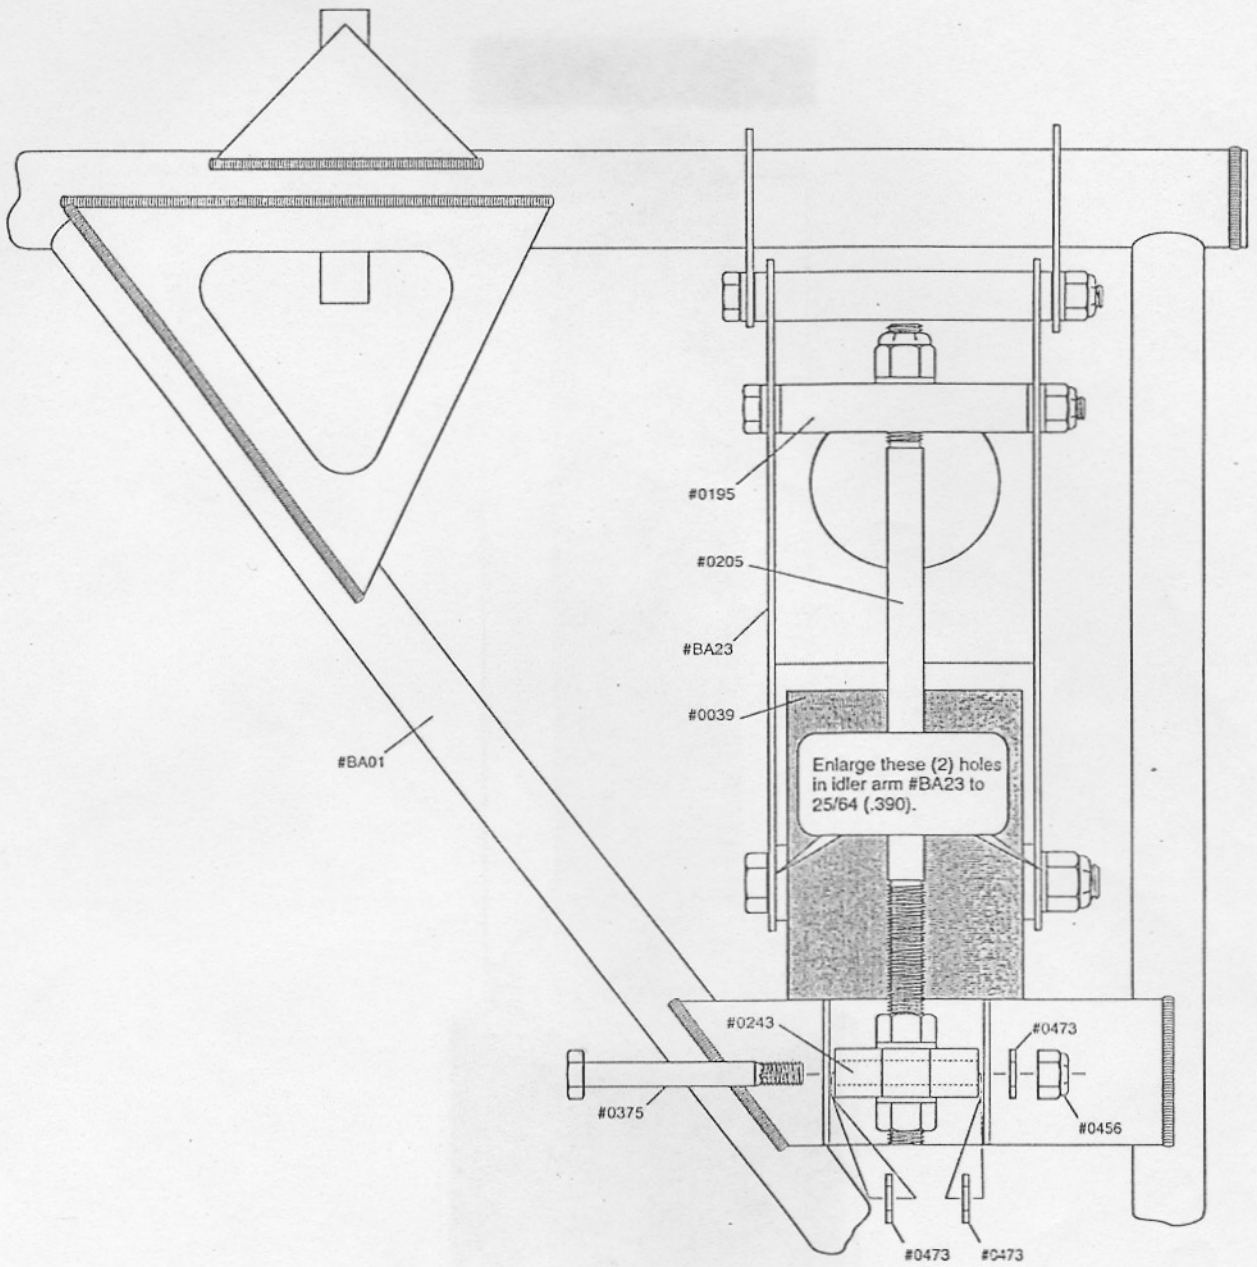
See diagram on back side.

1. Remove the main drive belt idler assembly from the aircraft.
2. Remove the idler wheel #0039 from the idler arm #BA23.
3. Enlarge the idler wheel mounting holes in the idler arm #BA23 to 25/64 inches (.390).

4. Reinstall the idler wheel #0039 to the idler arm #BA23 but do not tighten the bolt.
5. Reinstall the idler assembly onto the aircraft.
6. Align the idler wheel with the drive belt both vertically and horizontally, and tighten the bolt.

10. With the belt in the proper place on the bottom sprocket, check the top sprocket. **The belt must be at least 1/8 inch back from the front (transmission side), of the top sprocket when under a load.**

7. Retention the drive belt as per the assembly manual.
8. Check the belt track both with no load and under load.
9. The belt should not be pressing against the front or the back of the bottom sprocket. Running toward one side is acceptable as long as the belt is not pressing against the sides.

11. Make small adjustments to the idler wheel alignment until the proper belt track is achieved.
12. Check for proper belt tension.
